# Manhole Inspection Summary

Manhole # S51C\_\_003MH

Insp Date: **5/2/08 11:23 AM**

**Location** Address: **201 n kenwood ave**

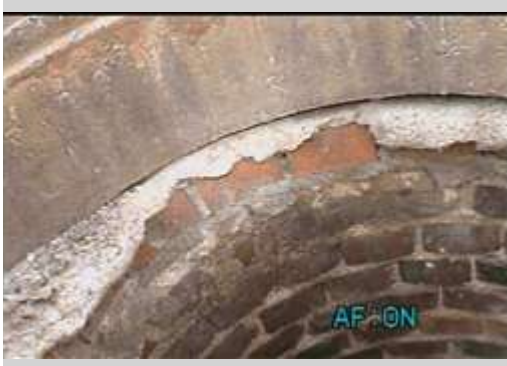
Defect 1

Condition: ☐ Sound ☐ Cracked ☐ Root Intrusion ☒ **Loose Brick** ☐ Deteriorated

frame adjustment

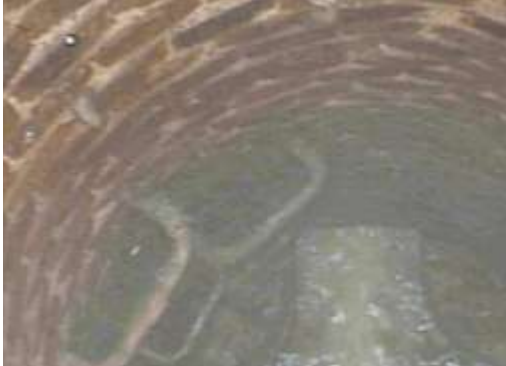
Defect 2

Count: **8** Missing: **2** ☒ **Corroded**

steps

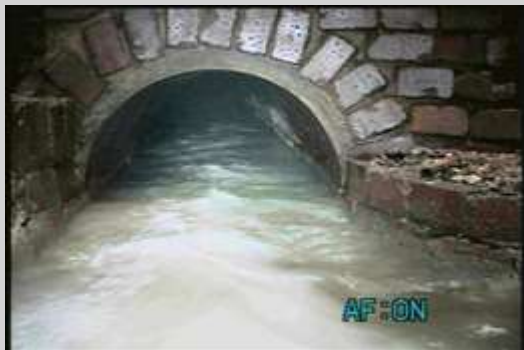
12 O'Clock Outflow

15 in. Circular Gravity Sewer  
Pipe Out @ 12 O'Clock

Pipe Material: **Clay** ☐ Pipe Lined

Invert Depth: 14.10 (ft.) Flow Characteristics: **Fast**

Infiltration: **None** Pipe Seal Cond: **Unknown**

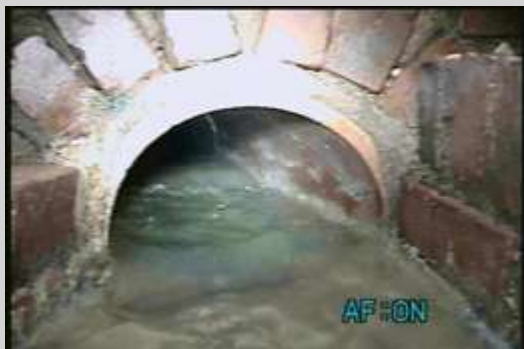
3 O'Clock Inflow

10 in. Circular Gravity Sewer  
Pipe In @ 3 O'Clock

Pipe Material: **Clay** ☐ Pipe Lined

Invert Depth: 13.64 (ft.) Flow Characteristics: **Fast**

Infiltration: **None** Pipe Seal Cond: **Unknown**

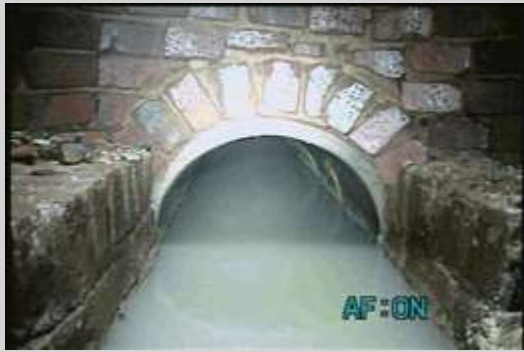
6 O'Clock Inflow

15 in. Circular Gravity Sewer  
Pipe In @ 6 O'Clock

Pipe Material: **Clay** ☐ Pipe Lined

Invert Depth: **13.85** (ft.) Flow Characteristics: **Fast**

Infiltration: **None** Pipe Seal Cond: **Unknown**

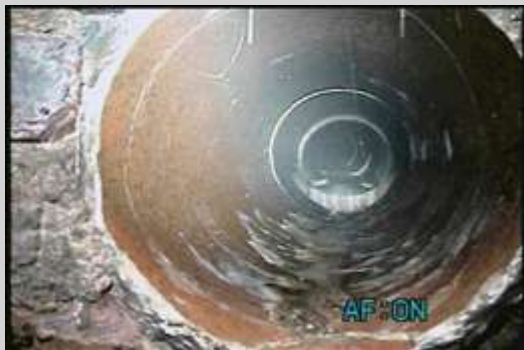
9 O'Clock Inflow

10 in. Circular Gravity Sewer  
Pipe In @ 9 O'Clock

Pipe Material: **Clay** ☐ Pipe Lined

Invert Depth: **9.85** (ft.) Flow Characteristics: **Fast**

Infiltration: **None** Pipe Seal Cond: **Unknown**

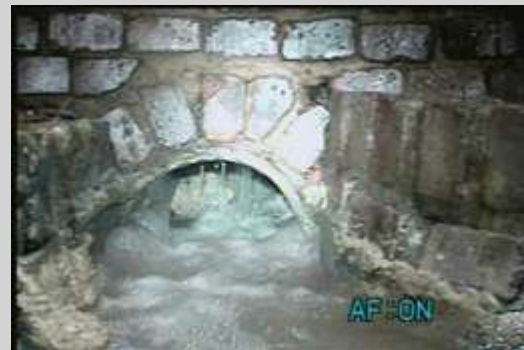
Drop In @ 9 O'Clock

Drop: **Inside** **Direct**

Inv Depth: **13.75** (ft.)

Drop Condition: **Open**
